Characteristics of earthquake- and rain-induced landslides near the epicenter of Wenchuan earthquake

S. Zhang ^{a,*}, L.M. Zhang ^{a,*}, T. Glade ^b

^a Department of Civil and Environmental Engineering, The Hong Kong University of Science and Technology, Clear Water Bay, Hong Kong

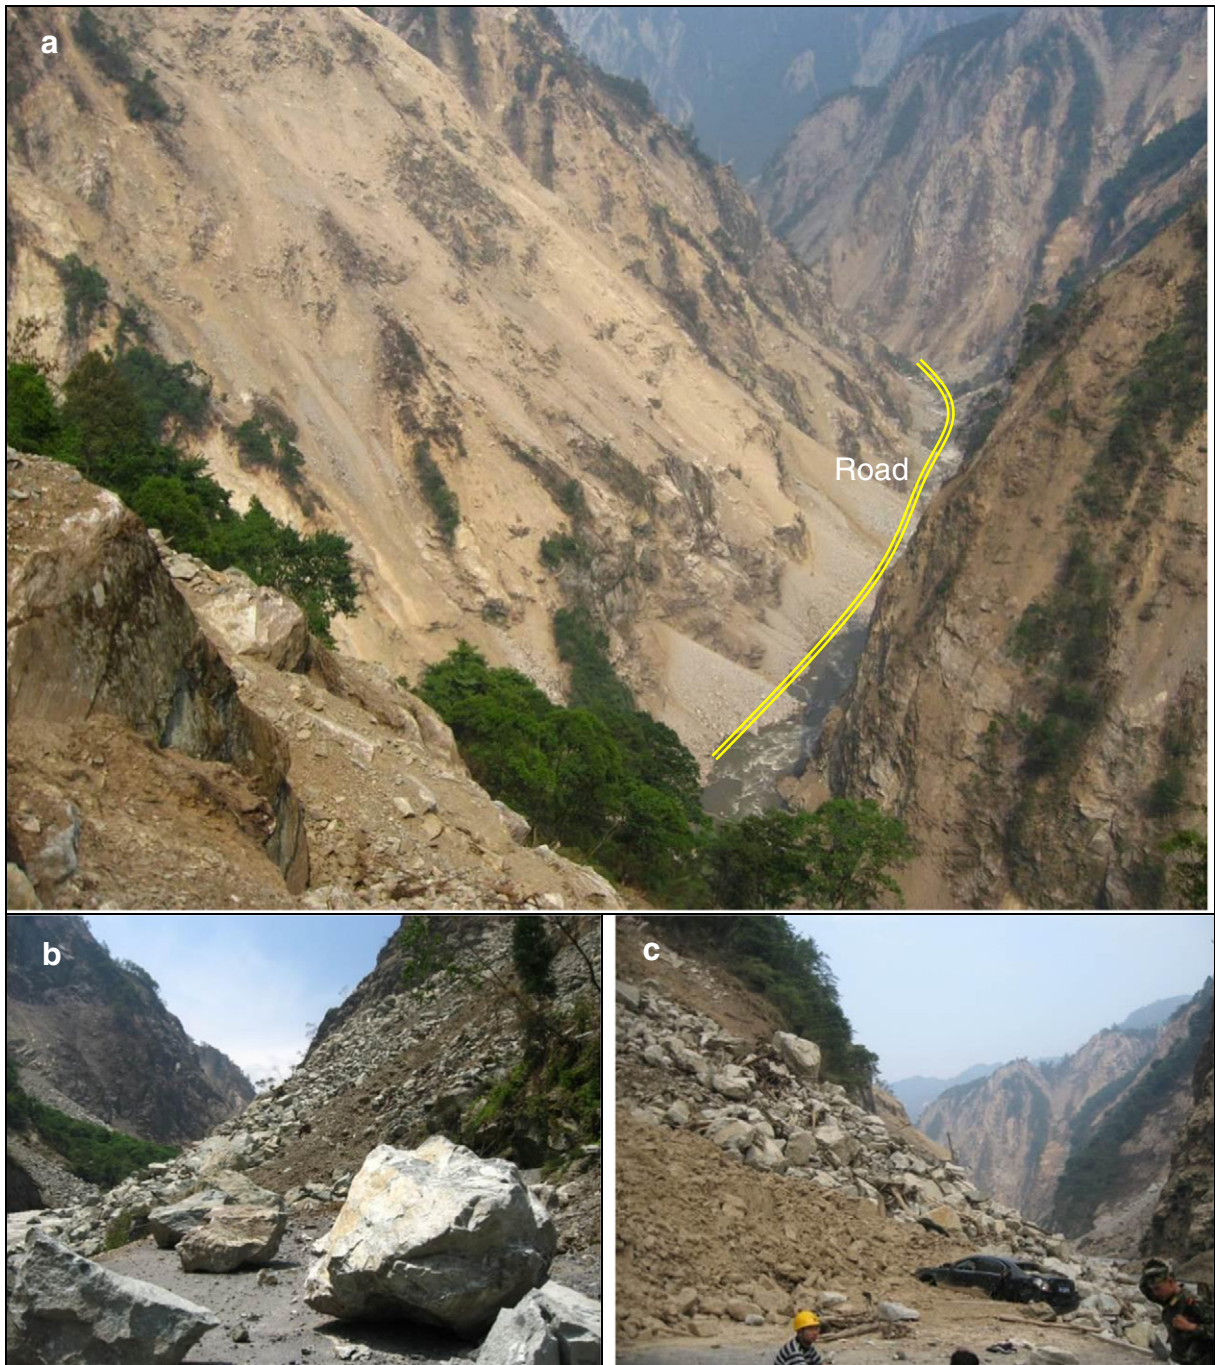
Fig. 7. Damage to the highway during the earthquake: (a) overall view; (b) damaged road; and (c) fatal landslide.

A comparison of the observed internal reliefs of the earthquake-induced landslides in the study area and in other regions affected by the Wenchuan earthquake was conducted. The latter data includes 71 earthquake-induced landslides in Beichuan, Anxian, Qingchuan, Pingwu, Maoxian, and Mianzhu reported in the literature (e.g. Cui et al., 2011; Xu et al., 2011). The internal relief values of 71% of the earthquake-induced landslides in these regions were between 0 and 600 m, and only those of 4% of the earthquake-induced landslides were above 1000 m. Indeed, the earthquake-induced landslides along PR303 have much higher internal relief values than the landslides in the rest of the parts of the Wenchuan earthquake zone. The steep topography and the dominant diorite and granite hard rocks in the study area are the main reasons for this (Figures 2, 3 and 7).

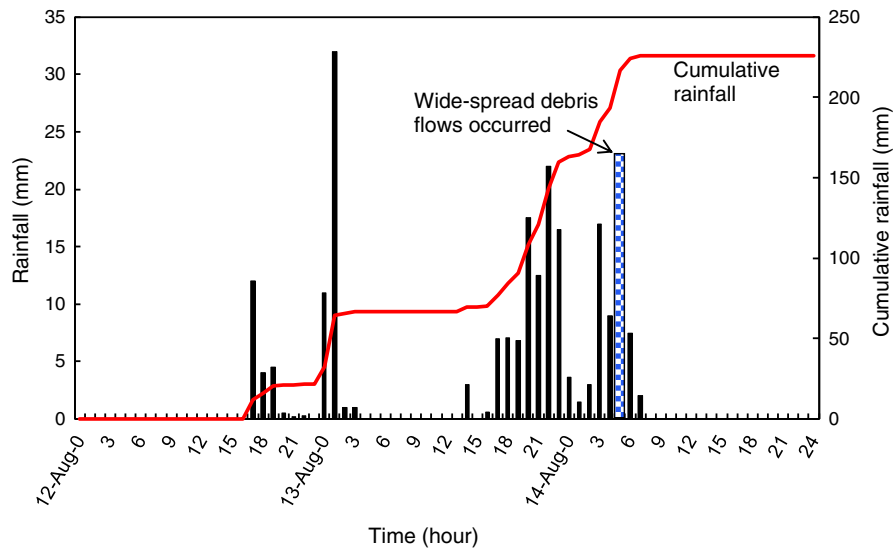
Fig. 9. Distributions of hourly and cumulative rainfall between 12 and 14 August 2010.

From 17:00 on 12 August 2010, a heavy rainstorm swept Yingxiu and its vicinity. The hourly and cumulative rainfall records are shown in Fig. 9. A cumulative rainfall of 226 mm was recorded within 39 h from 17:00 on 12 August to 7:00 on 14 August. Particularly, a cumulative rainfall amount of 185 mm was recorded by about 4:00 am on 14 August 2010, when local residents witnessed widespread landslides and debris flows in the study area (Figure 10).

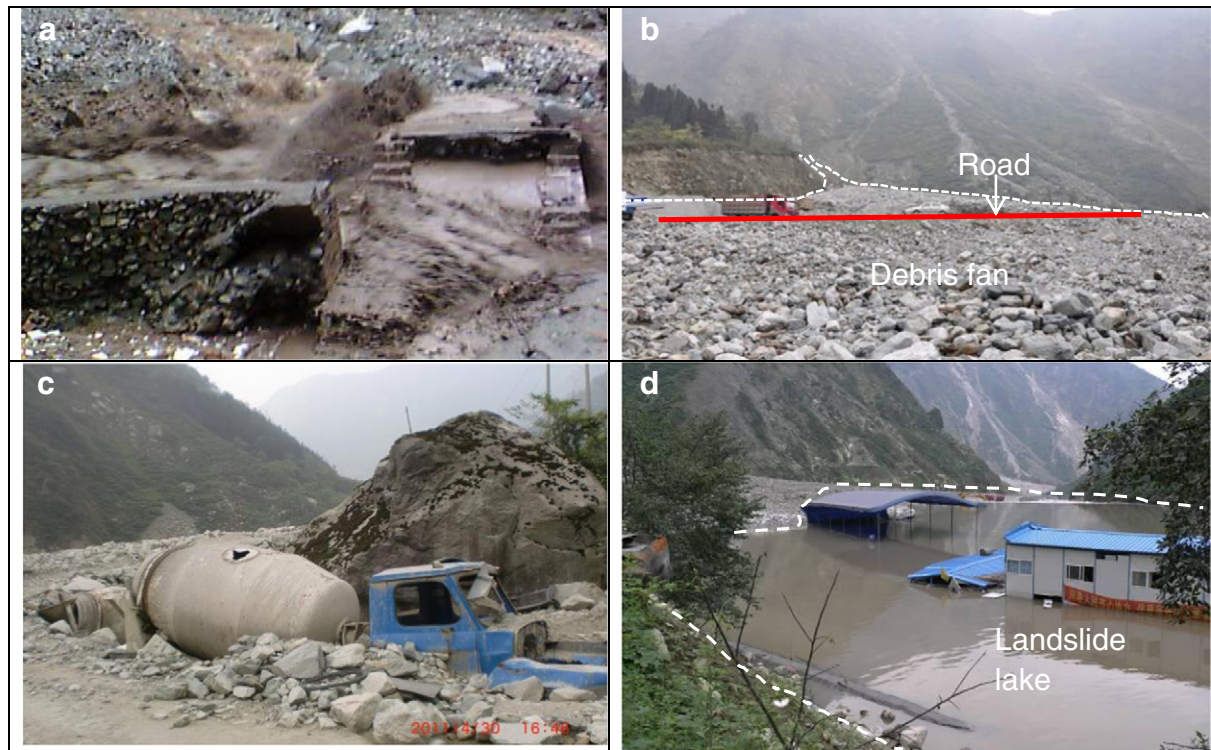
Fig. 13. Photographs taken shortly after the rainstorm: (a) occurrence of debris flow; (b) buried road under reconstruction; (c) fatalities; and (d) landslide lake.

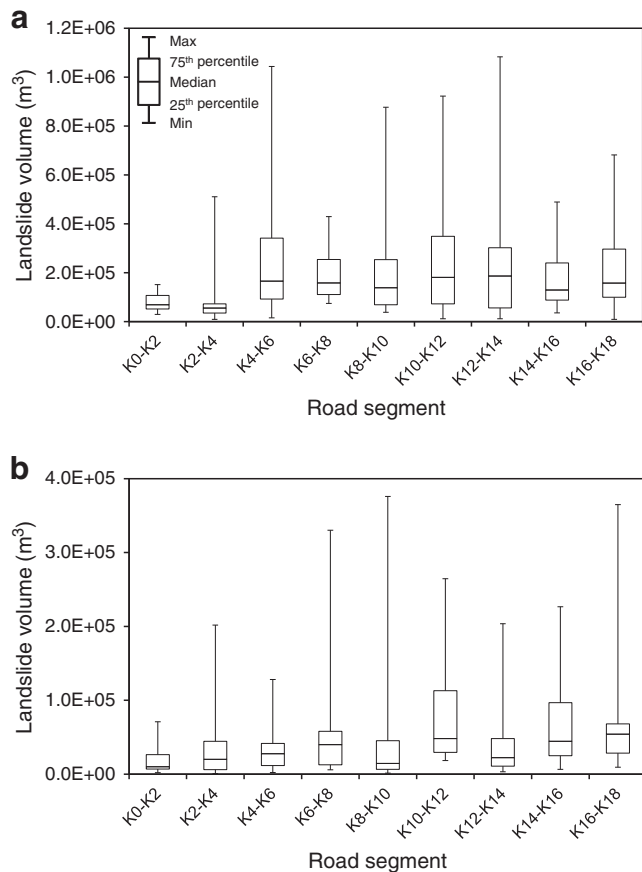
Fig. 14. Variation of volume of landslides along the highway: (a) shortly after the earthquake in 2008 and (b) shortly after the rainstorm in 2010.

In the study area, the distributions of the volume of landslides along the highway shortly after the earthquake in 2008 and after the rainstorm in 2010 are shown in Fig. 14. The box plots display the full range of variations of landslide volume (from the minimum to the maximum) in every 2 km along the road. The total volume of the 305 hill-slope deposits shortly after the Wenchuan earthquake was 54.30 million m^3 and the total volume of the channel deposits was 12.39 million m^3 (Table 2). The August 2010 storm triggered 351 fresh landslides but the total volume of these landslides was significantly smaller than that triggered by the earthquake in 2008 (Figure 15). The volumes of the hill-slope deposits from the reactivation landslides, new landslides and original landslides were 15.42, 1.52 and 31.28 million m^3 , respectively. However, the amount of channel deposits increased obviously after the storm in 2010, with a total volume of 16.94 million m^3 (Table 3).

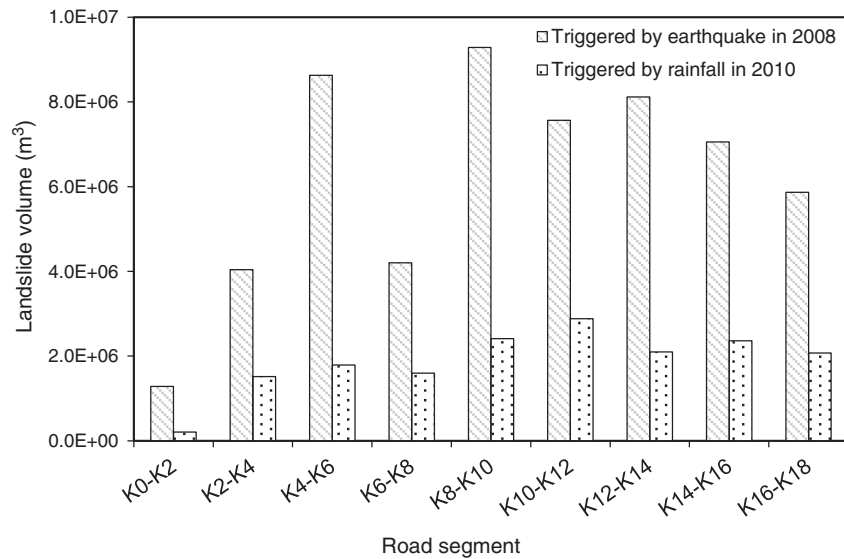
Fig. 15. Comparison of total volumes of landslides triggered by the earthquake in 2008 and the rainstorm in 2010.

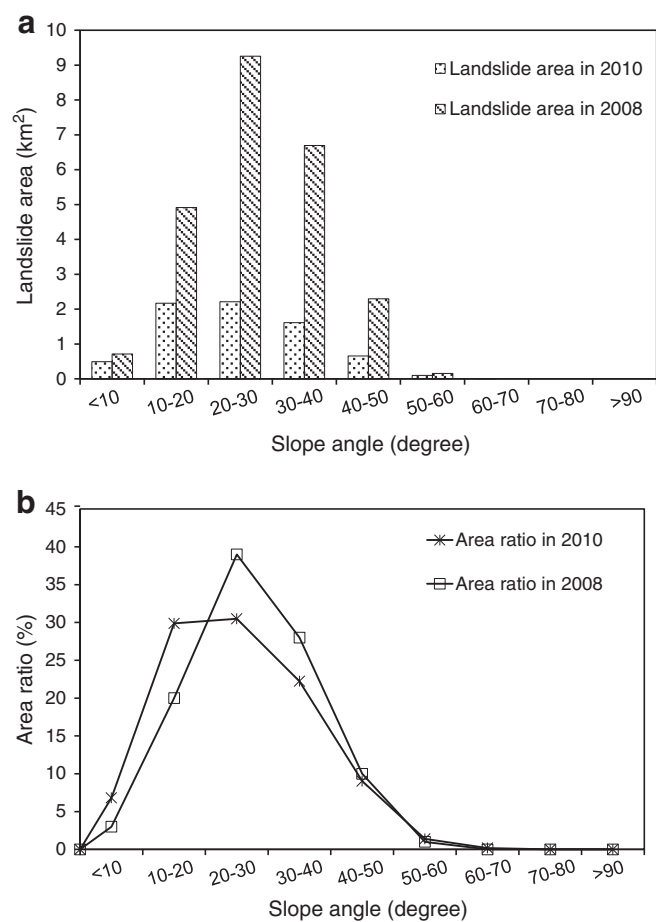
Fig. 18. Distribution of landslides of different slope angles: (a) landslide area; (b) area ratio.

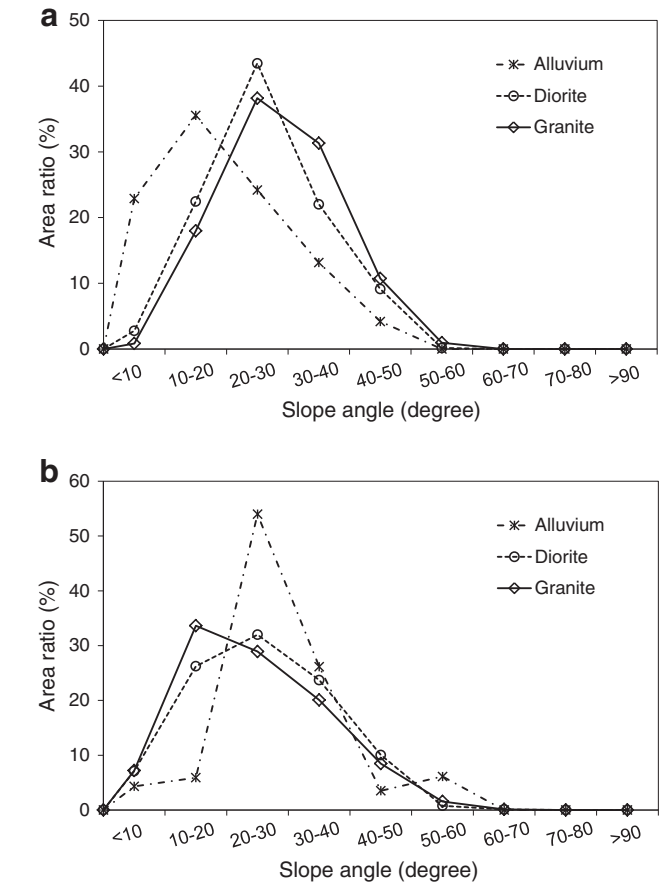
Fig. 21. Landslides in different lithology units: (a) landslides in 2008 and (b) landslides in 2010.

the distribution of landslides in different lithology units are presented in Figs. 20 and 21. The granite zones have the largest area of landslides, which is 13.60 km² in 2008 and 3.97 km² in 2010 (Figure 20). During the earthquake, the landslides were mainly concentrated in diorite and granite zones at the mean slope angles of 30°–50° up to a maximum of 65°. The landslides in the alluvium zone were mainly distributed on terrains at the mean slope angles ranging from 10° to 30° (Figure 21a). In 2010, the fresh rain-induced landslides in diorite and granite were mainly concentrated at the mean slope angles of 20°–40°, while most of the fresh rain-induced landslides in alluvium were distributed at the mean slope angles of 15°–45° due to the increased shear strength from the presence of soil matric suction. Particularly, new rain-induced landslides in alluvium with an area ratio of 6.1% were recognized in cut slopes with the slope angles of 50°–60° (Figure 21b). The area ratio is defined as the
